ERDC/CHL TR-01-26

# **Impacts of Navigation Channel Maintenance Dredging on the Coastal Processes of Chatham, Massachusetts**

Donald K. Stauble

September 2001

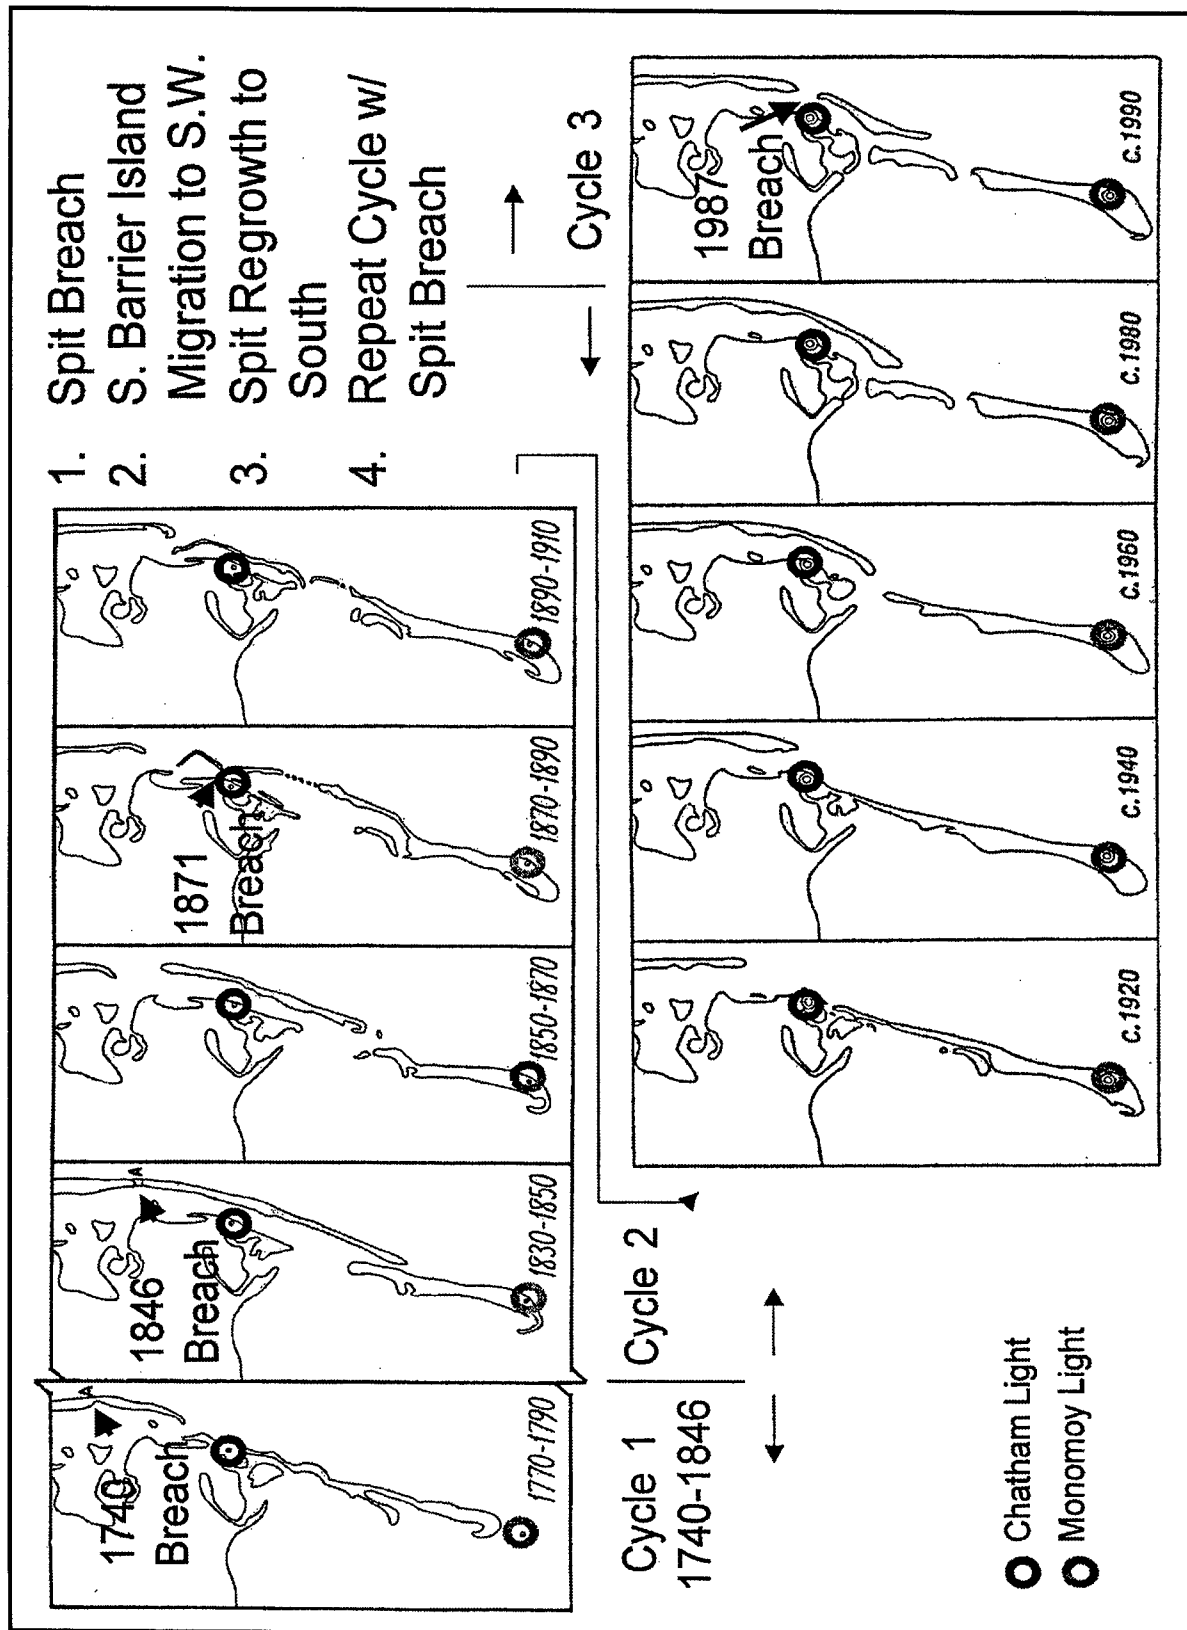
Figure 2. Cyclic change in Chatham shoreline since 1770s (after Giese 1988)

Historically, this barrier system has an approximate 140-year cycle of barrier spit growth and inlet formation (Giese 1988). The cycle starts with the growth of Nauset Spit southward from the mainland sea cliffs of Eastham and Wellfleet. The spit migrates southward with the prevailing longshore drift until a storm occurs and a breach breaks through a weak point in the barrier, creating a shortened spit and a detached barrier island from the southern portion of the spit. This southern barrier continues to migrate to the south and west and eventually welds to the mainland. Charts and other records dating back to the 1700s indicate that an inlet

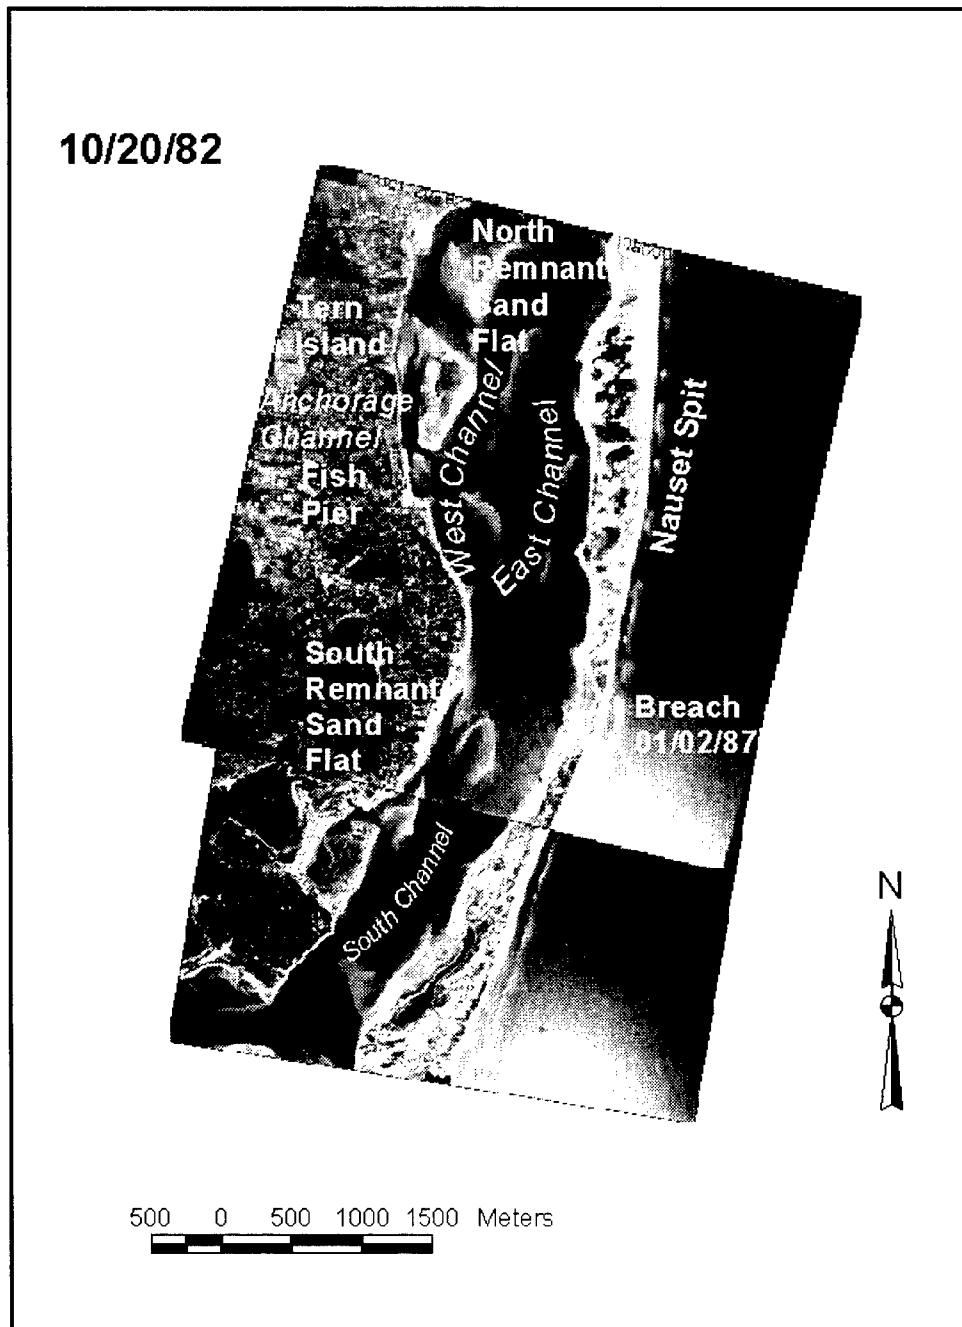
Figure 5. Preinlet morphology of Chatham Harbor, 20 October 1982

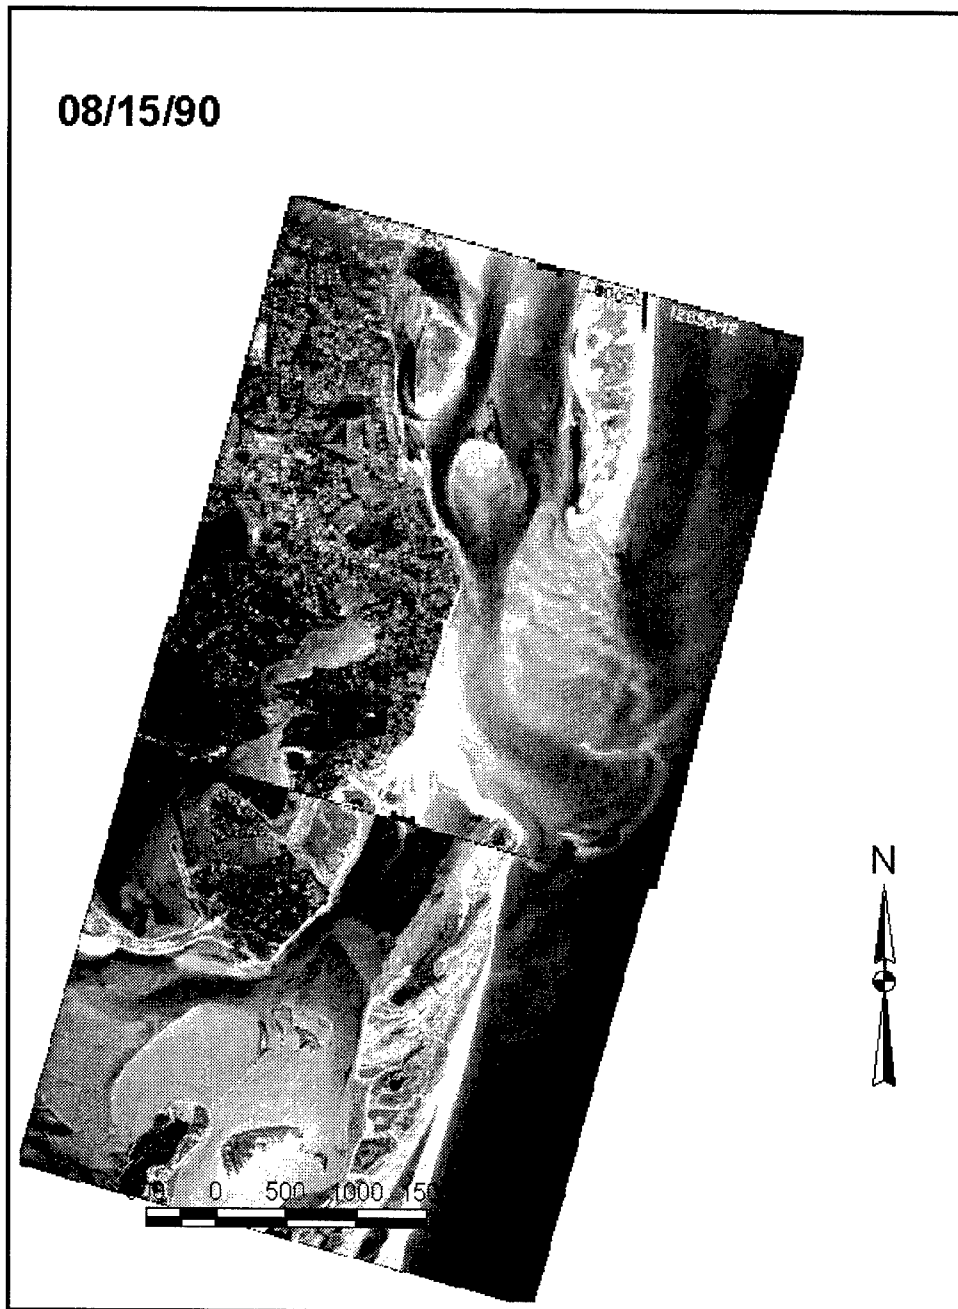
Figure 9. Morphology of Chatham Harbor, 15 August 1990

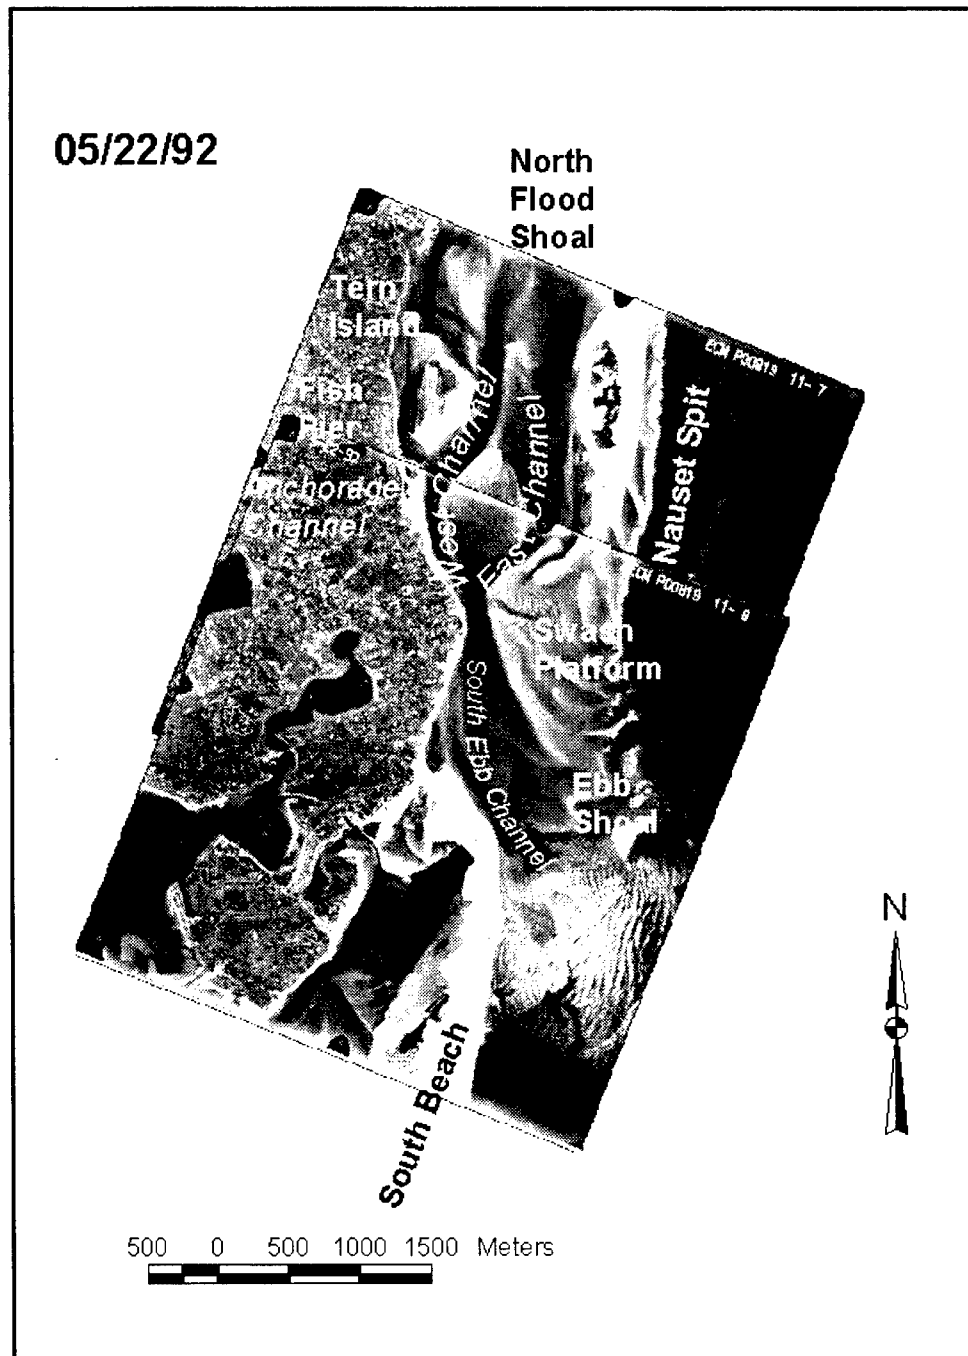
Figure 10. Morphology of Chatham Harbor, 31 December 1991

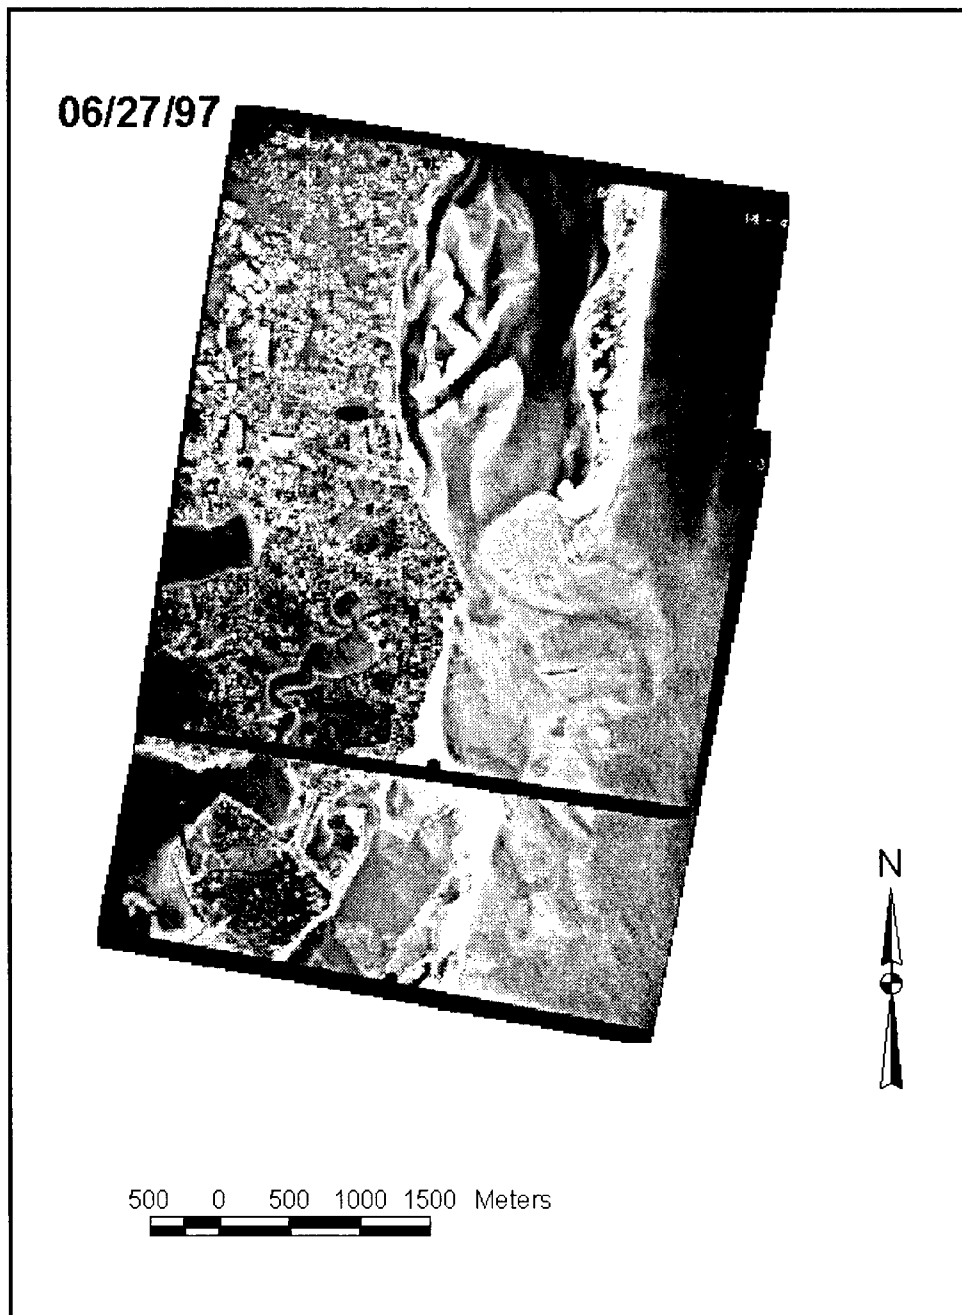
Figure 17. Morphology of Chatham Harbor, 27 June 1997

provide access from Aunt Lydia's Cove to the southern end of the flood ramp. The eastern channel had naturally re-established a navigable passage along the eastern side of Chatham Harbor to Pleasant Bay. The large ebb shield at the northern end of the flood shoal was restricting the flow up the estuary, and a large ebb-orientated spillover lobe formed at about the same location as the former west channel prior to the breach.

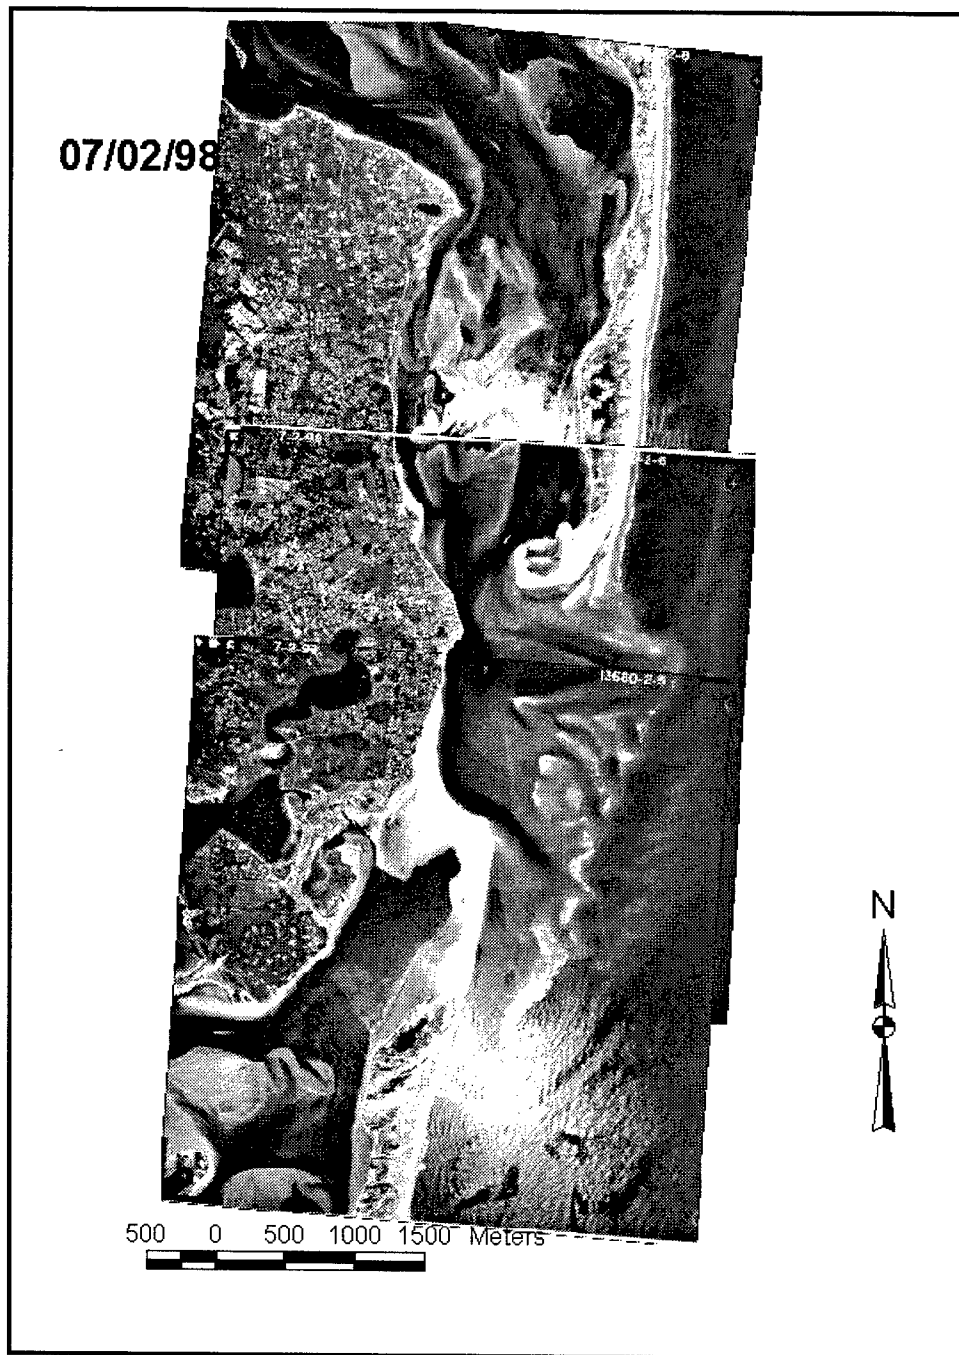
Figure 18. Morphology of Chatham Harbor, 2 July 1998

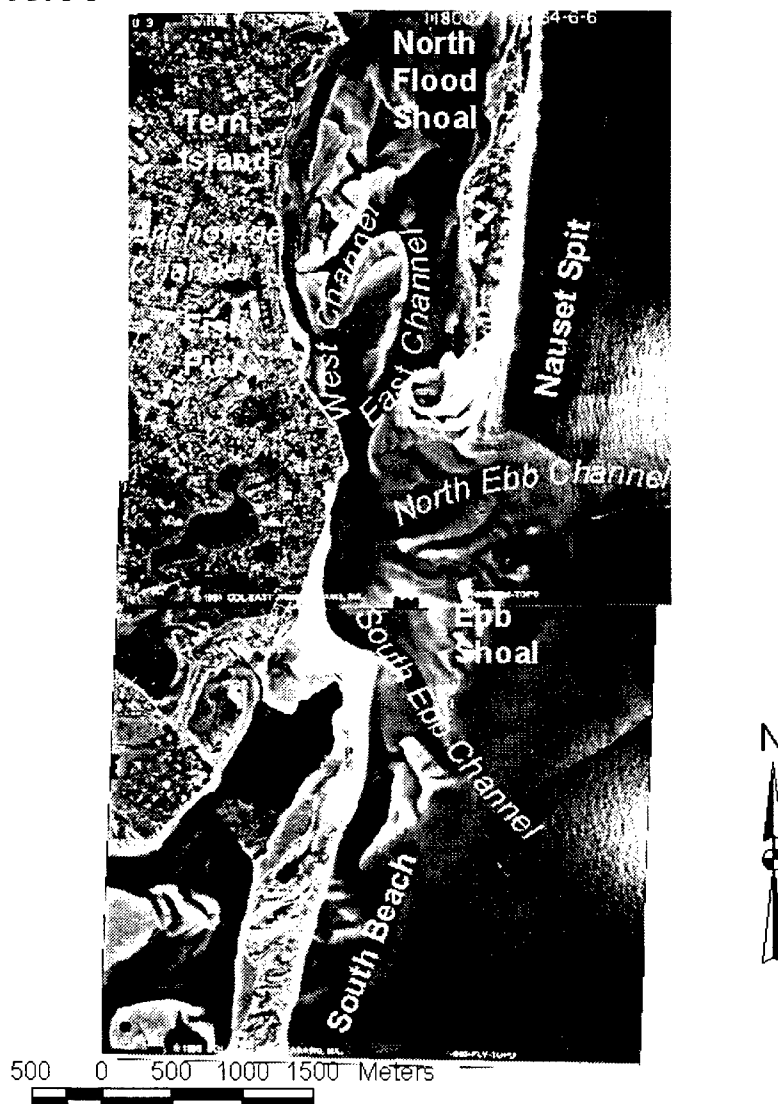
07/15/99

Figure 19. Morphology of Chatham Harbor, 15 July 1999

Twelve years after the initial breach, Chatham Inlet has still retained a highly dynamic morphology. Figure 19 shows the inlet as of 15 July 1999. The linear shoals continue to gain sand on the expanding ebb shoal. With the increasing dominance of the meandering northern ebb channel, the ebb shoal is expanding seaward on the north end. At the same time it is migrating further to the south, creating substantial shoals and making navigation through the southern ebb channel a challenge. A new ebb-orientated spit has formed at the tip of South Beach. The south channel has been pushed against the mainland shore as the ebb

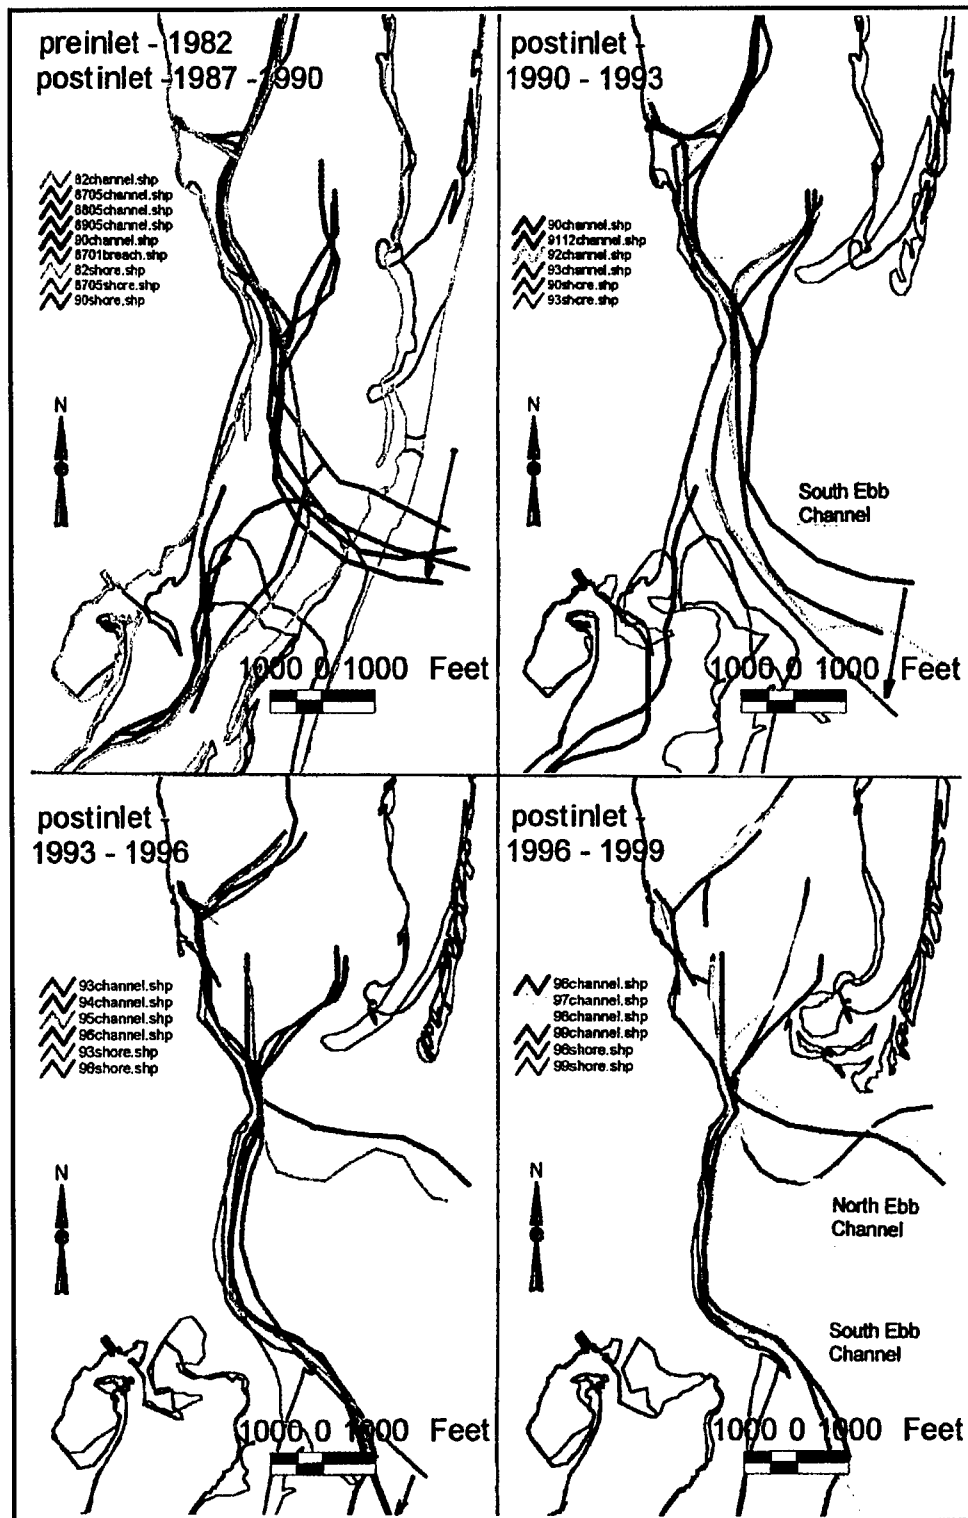
Figure 21. Change map of ebb channel center lines

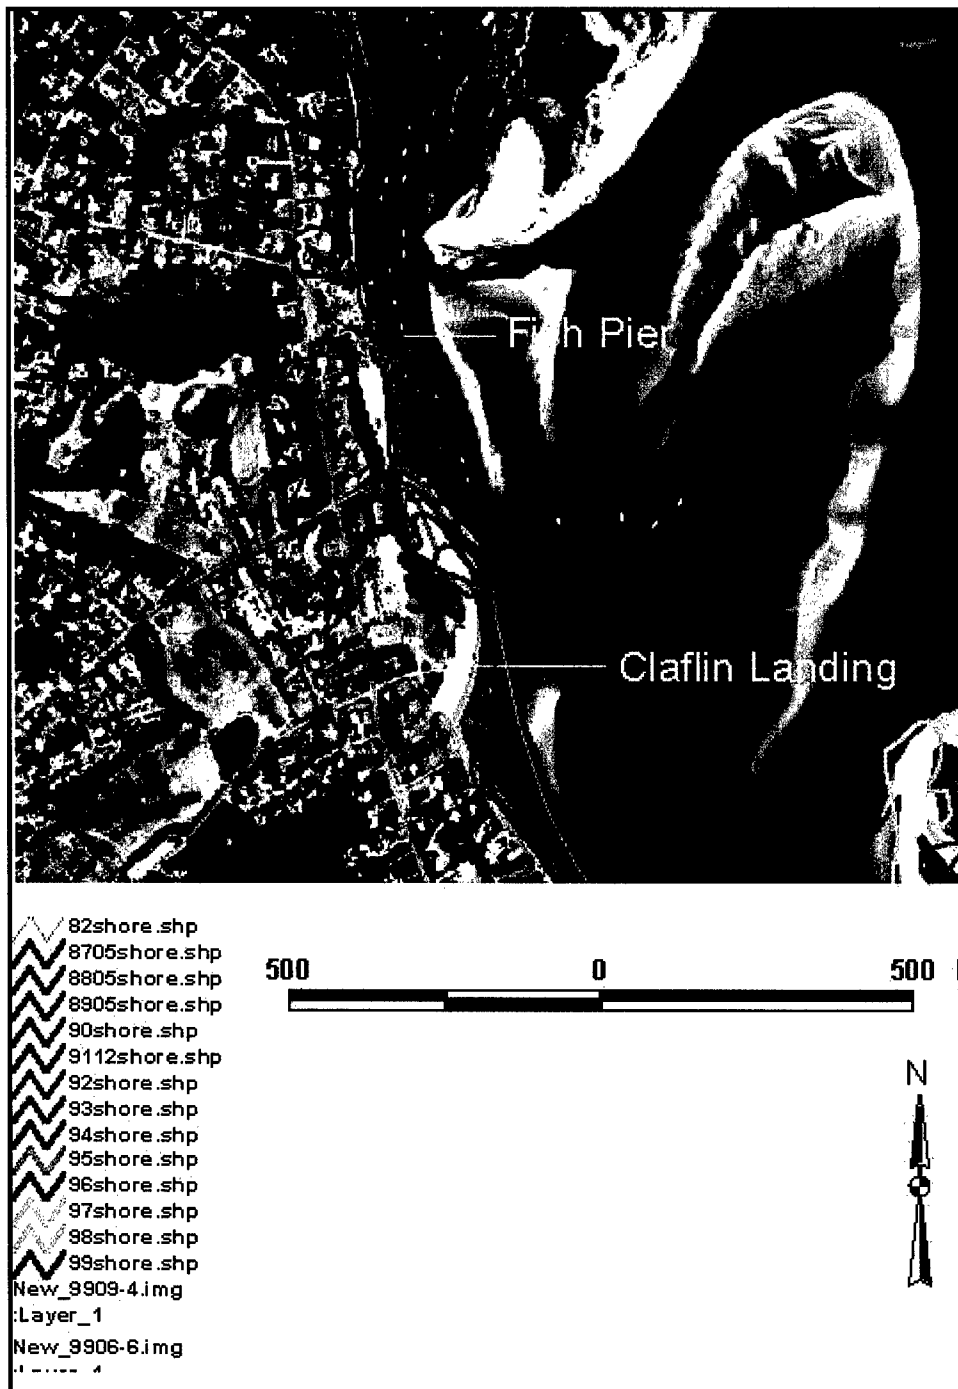
Figure 22. Mainland shoreline change in Aunt Lydia's Cove (Cow Yard Landing to Claflin Landing)

Part of segment 1, north of the Fish Pier extending from Cow Yard Landing to the Fish Pier has been protected from waves and tidal currents by Tern Island and the extensive shoals on the north end of Tern Island. This mainland shoreline in Aunt Lydia's Cove, behind Tern Island has changed little throughout the study period (Figure 22). The shore is composed of a narrow width of sand and some marsh. In contrast, south of the Fish Pier the shoreline reach extending to Claflin Landing has undergone extensive change. This area of the Cove's shoreline has been influenced by the changes in the south Tern Island shoal and later by changes in the navigation channel and western ebb spit of the north flood shoal. South of Claflin Landing, the shoreline experienced erosion and flood tidal currents have transported some of that sand northward. A spit formed at the southern point of Aunt Lydia's Cove in 1990 as the sand deposit started to grow north. This spit progressed to the north in yearly increments until 1996 when the accretion formed a wide beach in that area. Since 1996 the shoreline has remained in that position as the Tern Island shoal eroded and the main channel has occupied the area just off the beach. The town has nourished the beach at Claflin Landing with an approximate total of 8,000 cu yd (6,117 m<sup>3</sup>) in May 1998 and May 2000.

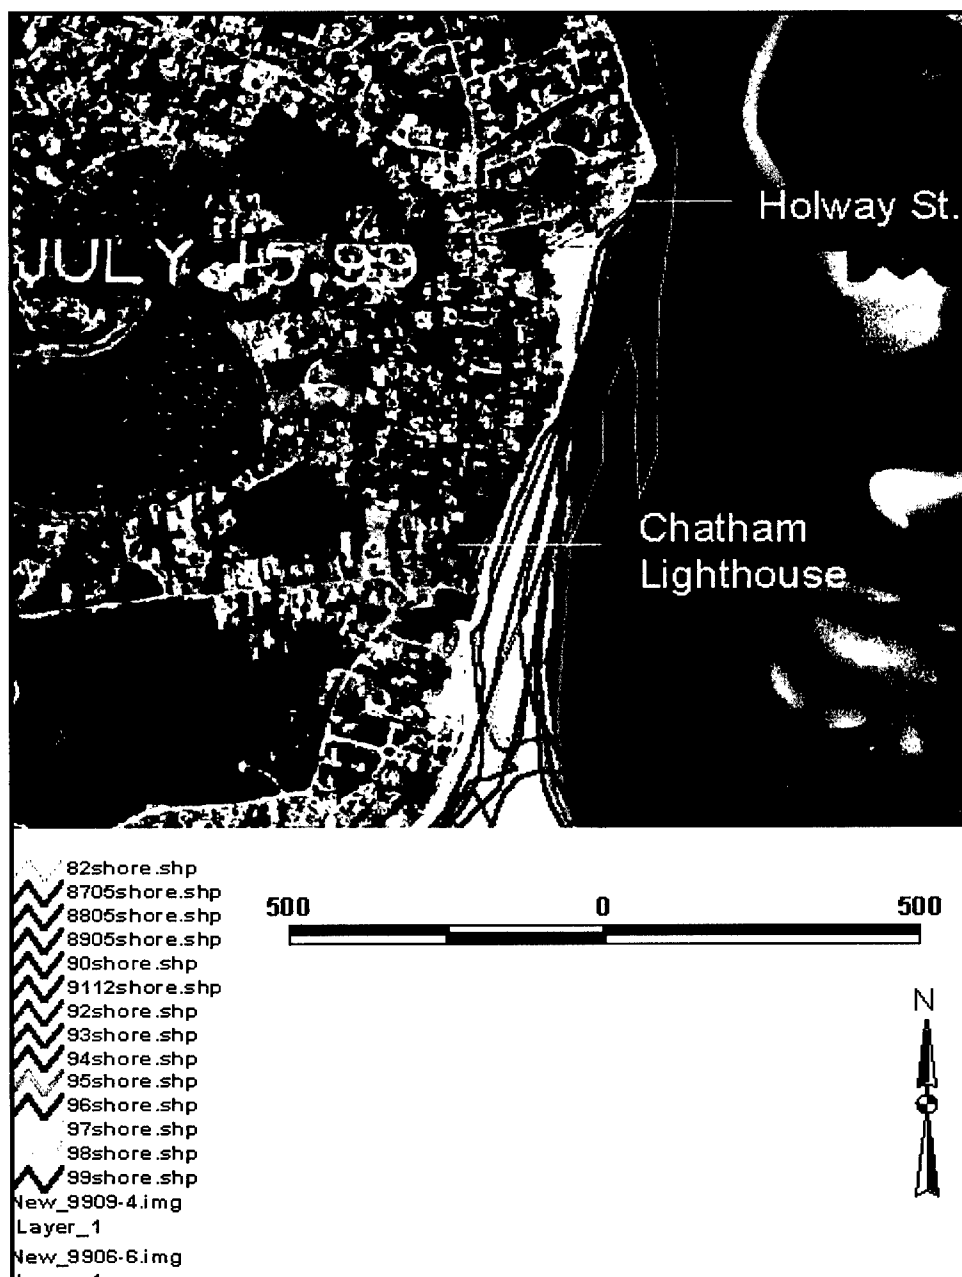
Figure 24. Mainland/South Beach shoreline change along the Chatham Lighthouse area (Holway Street to Chatham Lighthouse)

Preinlet conditions along the beach in front of Chatham Lighthouse from Holway Street to past the lighthouse included a 200-ft (61-m) wide beach with an ebb-orientated ebb spit. This segment 3 shoreline also began to erode immediately after the inlet opened, with the loss of some homes at the foot of Andrew Hardings Lane. A rock revetment was constructed at the foot of Water Street in the winter of 1987/1988. As the inlet opened, this beach segment continued to erode moving the shoreline landward to the base of the cliff until 1992, when the South Beach spit attached to the mainland (Figure 24). Then the shoreline on the southern end of the segment began to grow seaward again as sand was deposited on the beach as the South Beach attachment became larger. As of 1999 the shoreline had moved seaward some 300 ft (92 m) relative to the 1992 maximum retreat position. The north end of the segment from the south end of the large seawall at Holway Street to the smaller rock revetment has experienced a landward retreat to a maximum landward position in 1998. Around 25,000 cu yd (19,115 m<sup>3</sup>) of sand was placed on this beach from the navigation channel dredging into Aunt Lydia's Cove by the Town of Chatham in October 1998, May 1999 and October 1999. This nourishment has moved the shoreline seaward again around 50 ft (15 m). A rotational nodal point has developed in this segment around the small seawall at the foot of Water Street, with the north end moving landward and the south end moving seaward.

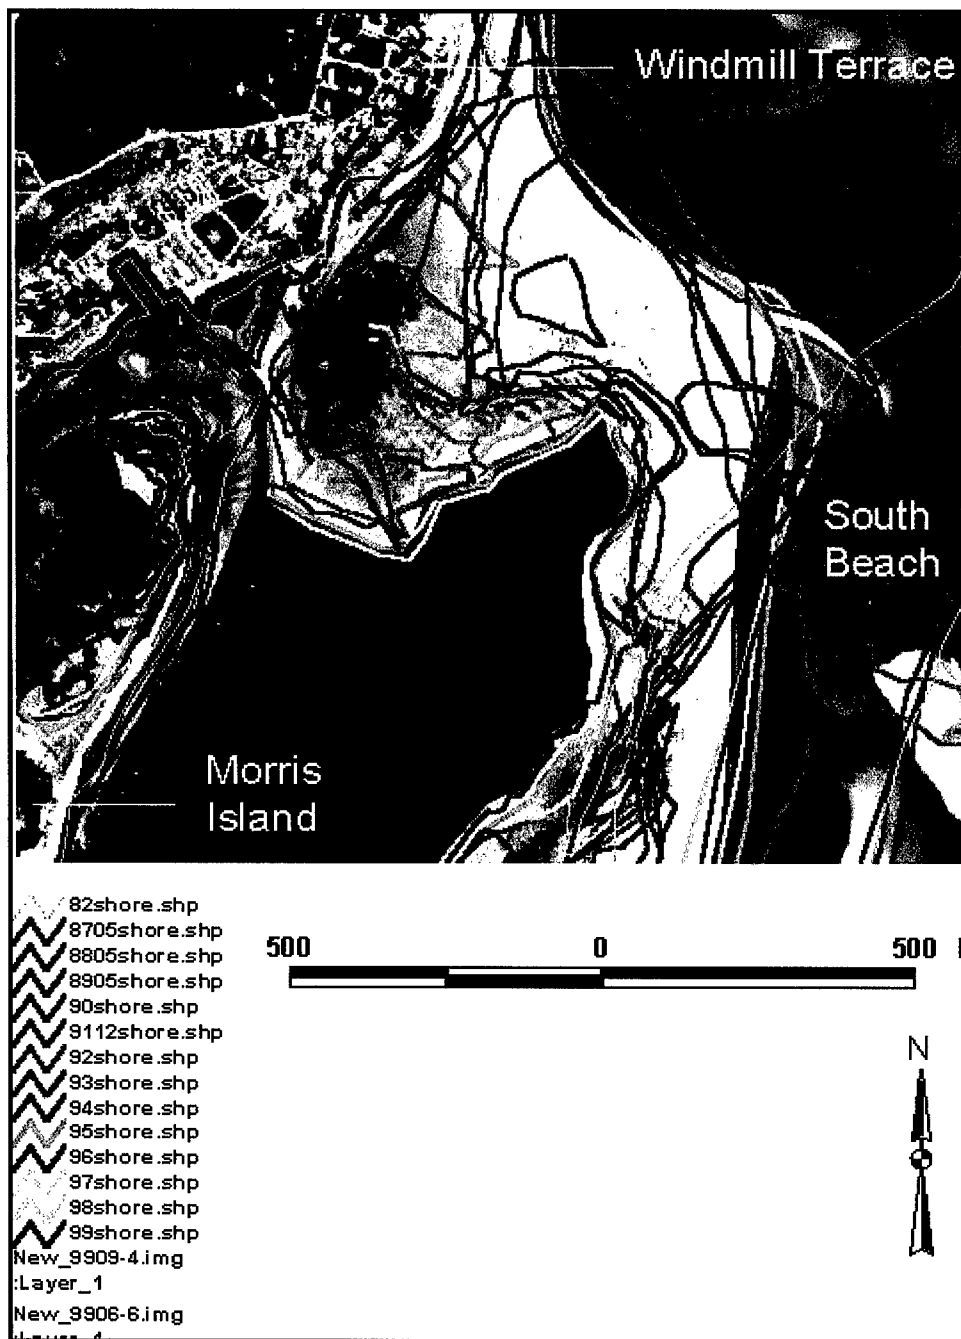
Figure 25. Mainland/South Beach shoreline change along Toms Neck (Chatham Lighthouse to Morris Island)

The most significant change in shoreline position has occurred in the fourth segment between Windmill Terrace and the dike to Morris Island. Preinlet conditions had a narrow shoreline curving back to a small marina (Figure 25). As the inlet opened up, some sand eroded from the mainland beach to the north was transported to this area and the shoreline moved seaward. As the spit recurved back from South Beach, sand detached from the spit and was added to the south flood shoal, with some sand making it to the mainland shore in this area. As the south flood shoal expanded in area and the South Beach spit grew, the tidal flow into south Chatham Harbor became restricted to two channels and finally one channel adjacent to the mainland. The south remnant shoal became attached to the south flood shoal and the mainland shore as a spit in 1989. As a result the shoreline moved seaward. The biggest change occurred when the South Beach spit attached to the mainland in early 1992, effectively cutting off tidal flow to south Chatham Harbor. The resulting land bridge joined the mainland shoreline to the South Beach ocean shore. Overwash of this area resulted in expansion of this land bridge, infilling the former south flood shoal with sediment. The South Beach attachment to the mainland still has limited elevation, with some well established

dunes and large areas of tidal flats on the inside. The area has expanded over the 1992-1999 time period and now is dry except for overwash at the elbow of South Beach during the highest storm tide levels. The outer shoreline of the north end of South Beach has moved landward some 1,300 ft (396 m) as the island, turned spit, migrates toward the mainland.

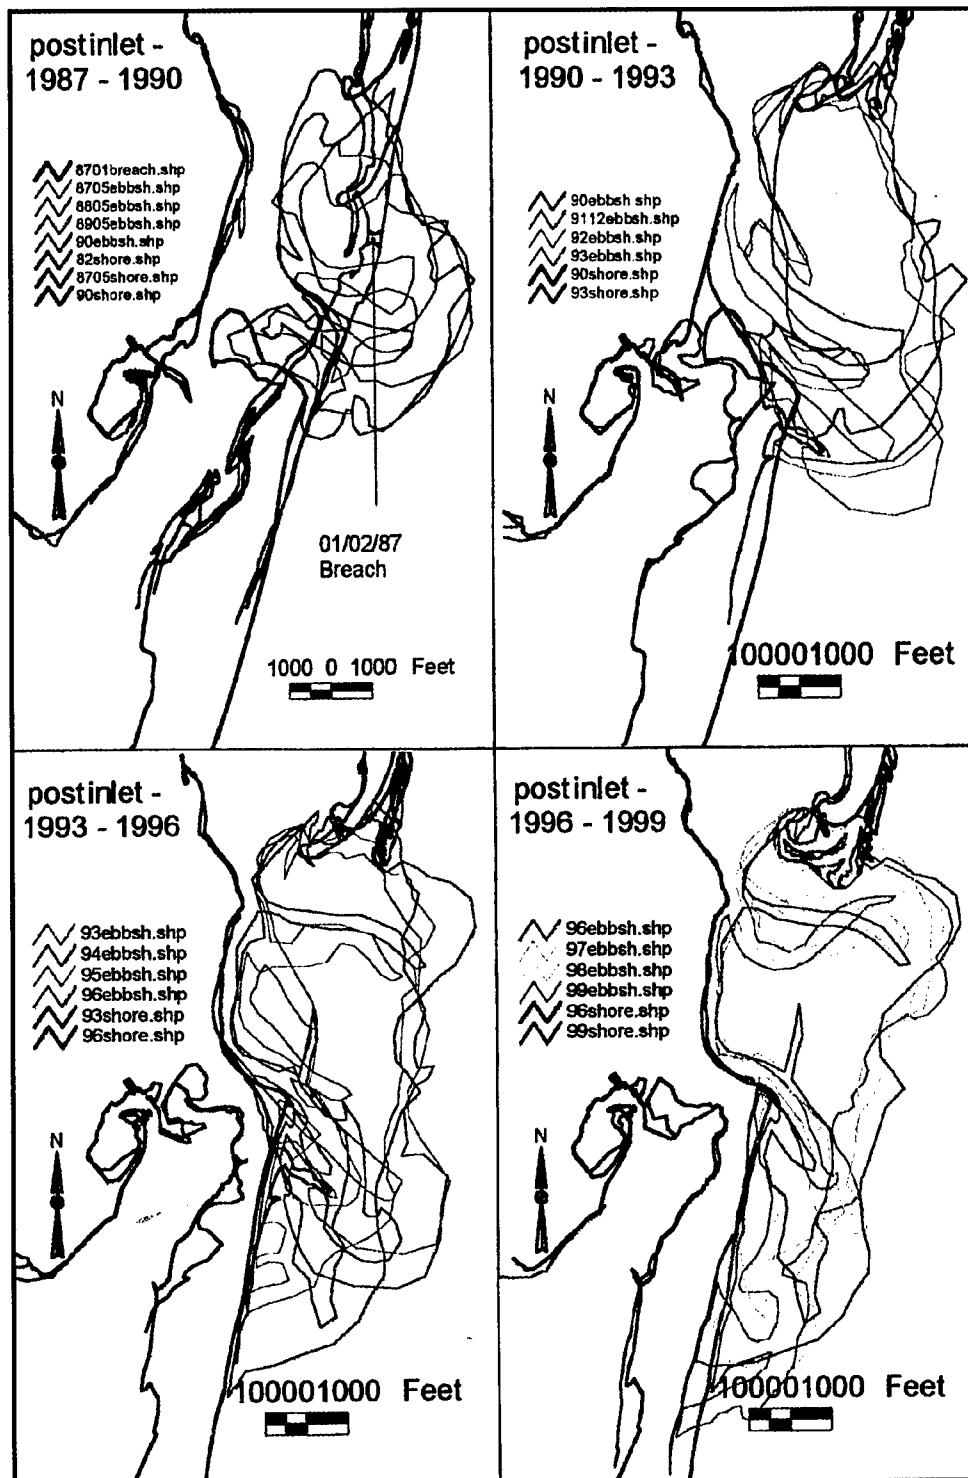
Figure 26. Map of growth in area of ebb shoal/swash platform

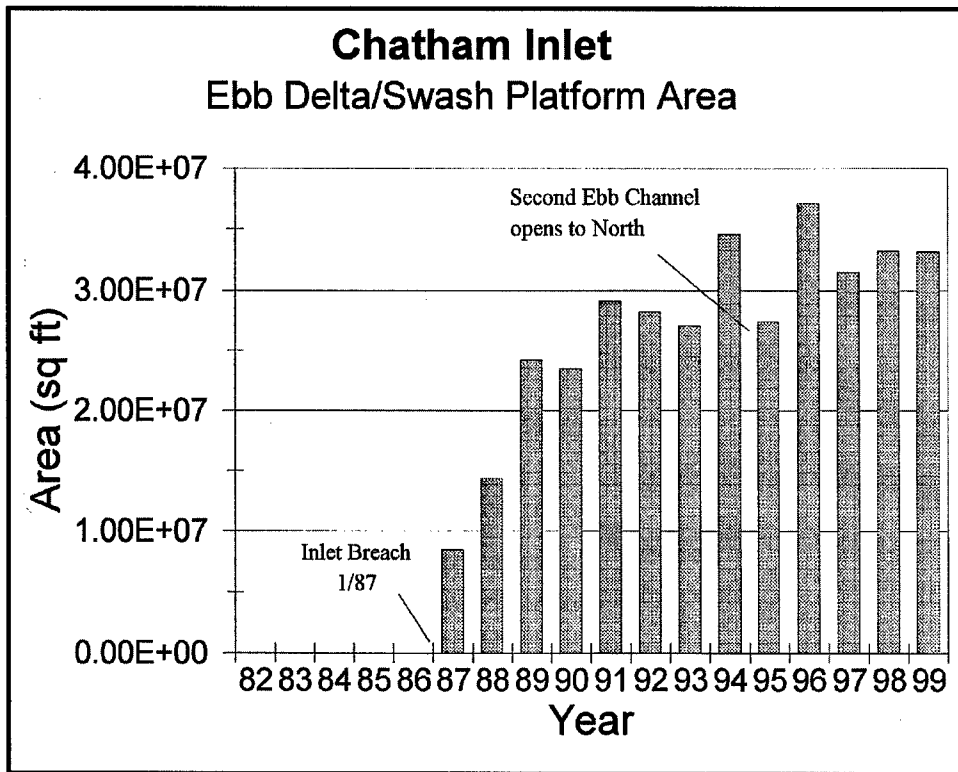
Figure 27. Postbreach area changes to ebb shoal/swash platform

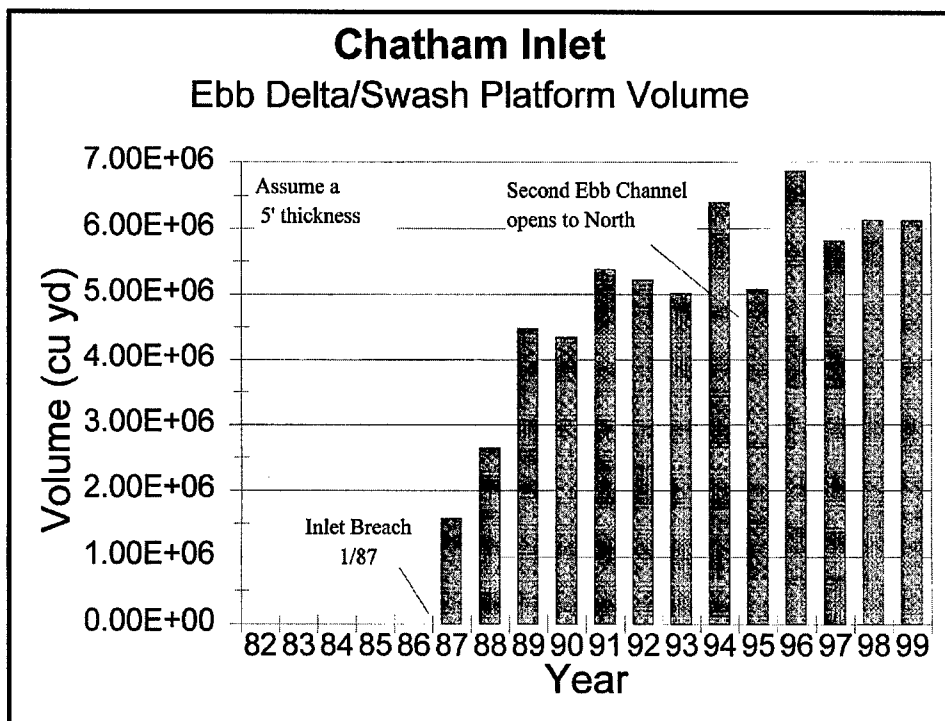
Figure 28. Estimate of volume change in ebb shoal/swash platform

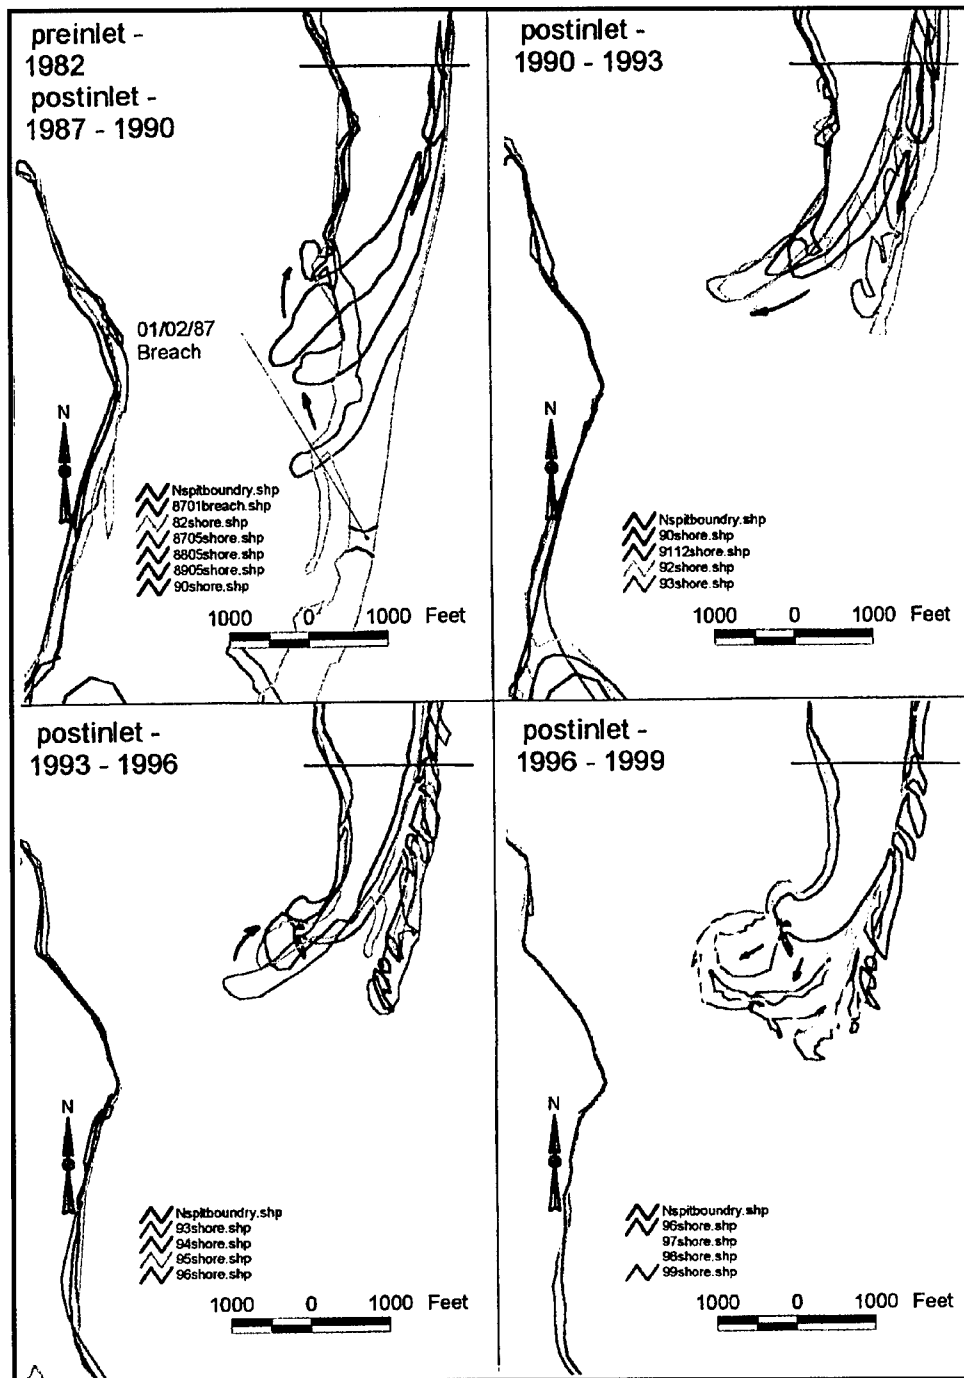
Figure 29. Map of area change to north spit. Line identifies common northern limit of area measurement

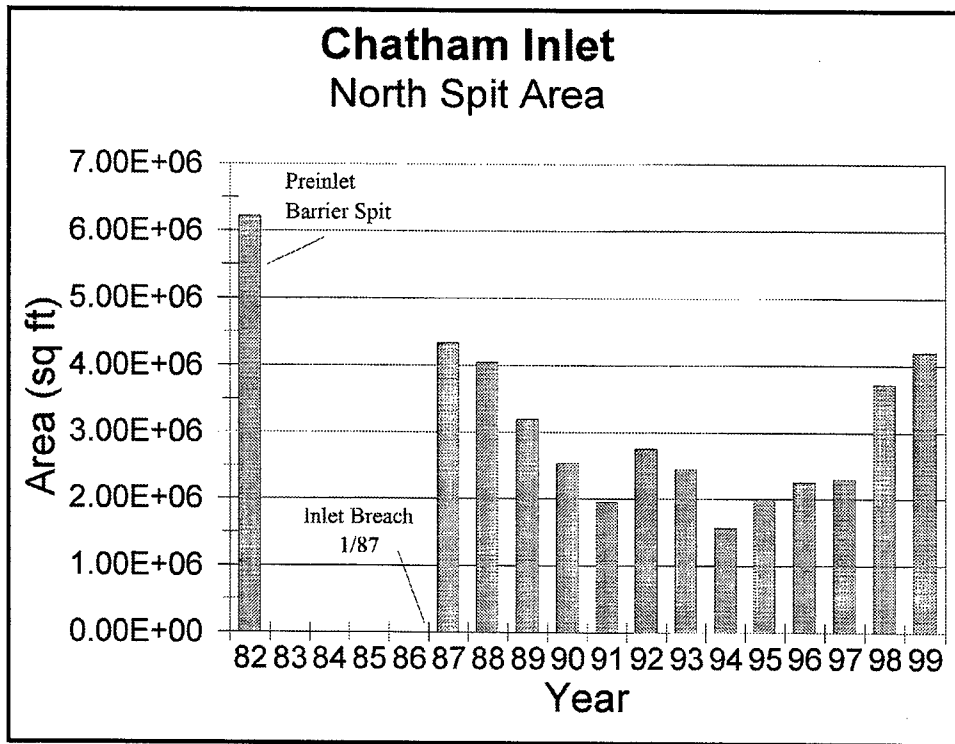
Figure 30. Area change from prebreach to 1999 of north spit

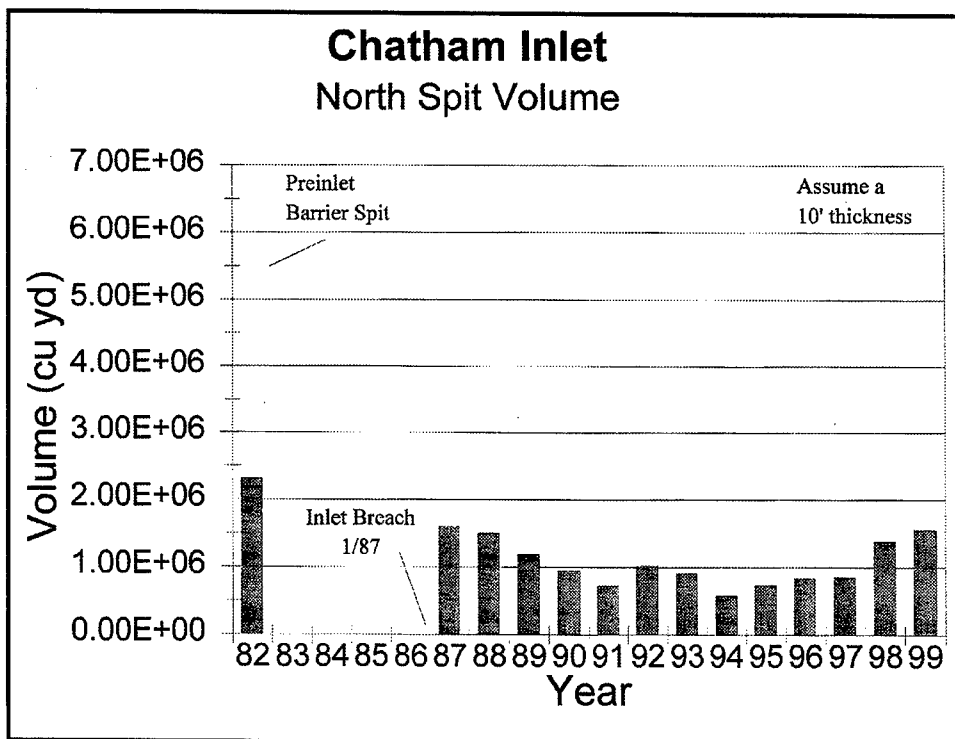
Figure 31. Estimate of volume change in north spit
